BULGARIAN FIGHTER COLOURS 1919–1948

Vol. 1

Rainbow No 9136

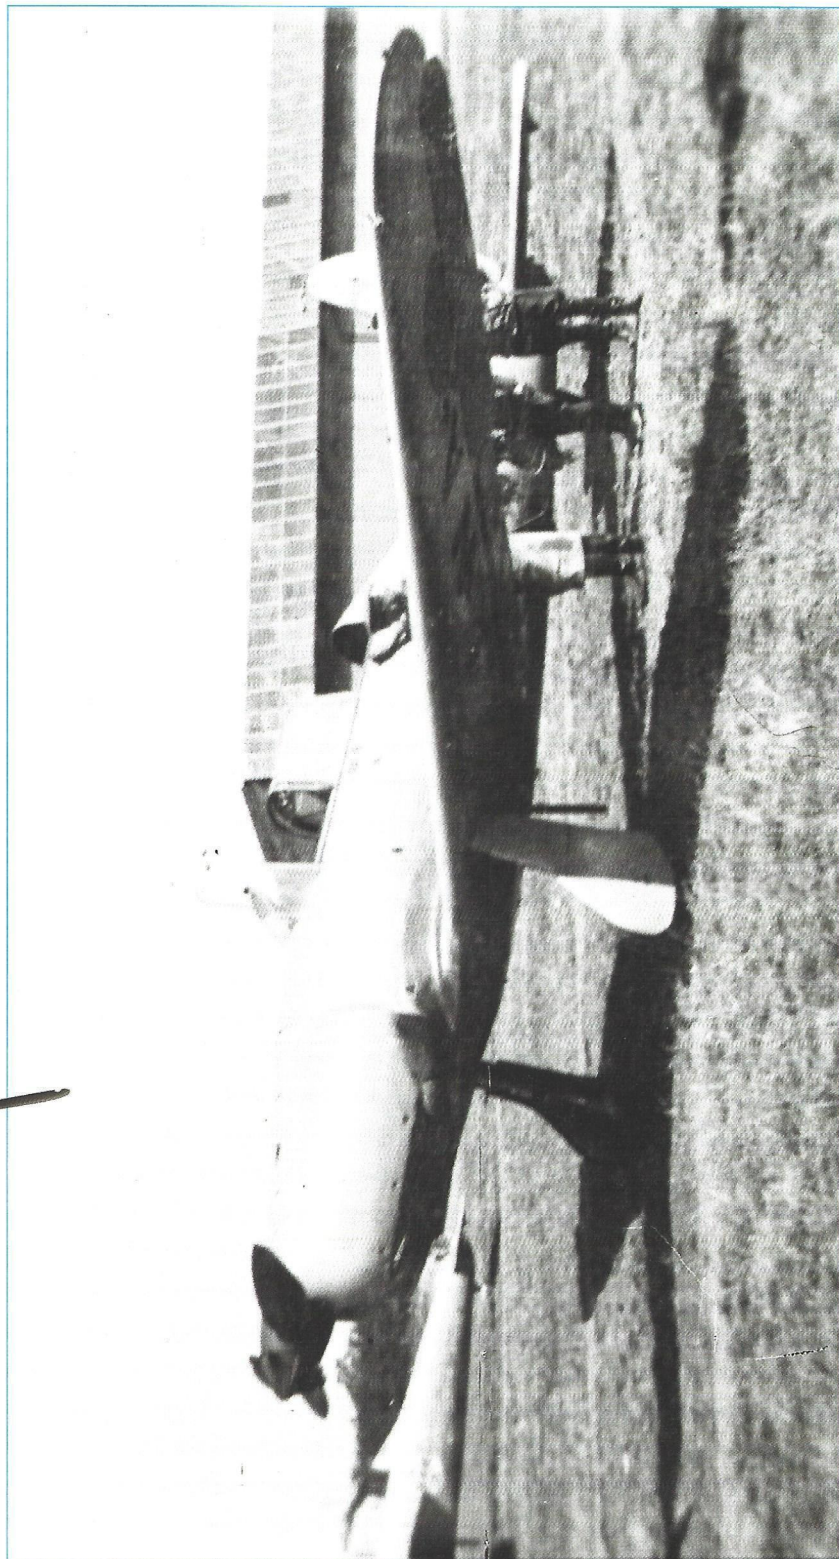
Depicted are the first unarmed Arado Ar 96B-1 trainers to arrive to Bulgaria in September 1940. The temporary civilian ferry registration was washed of the fuselage, revealing the Bulgarian military marking. The German registration was left untouched on the wing undersurface (...WA). This identifies the aircraft in the foreground as the first Ar 96B-1, D-IXWA, WNr. 96 0060 (future NN 1/7035 in Bulgarian service).

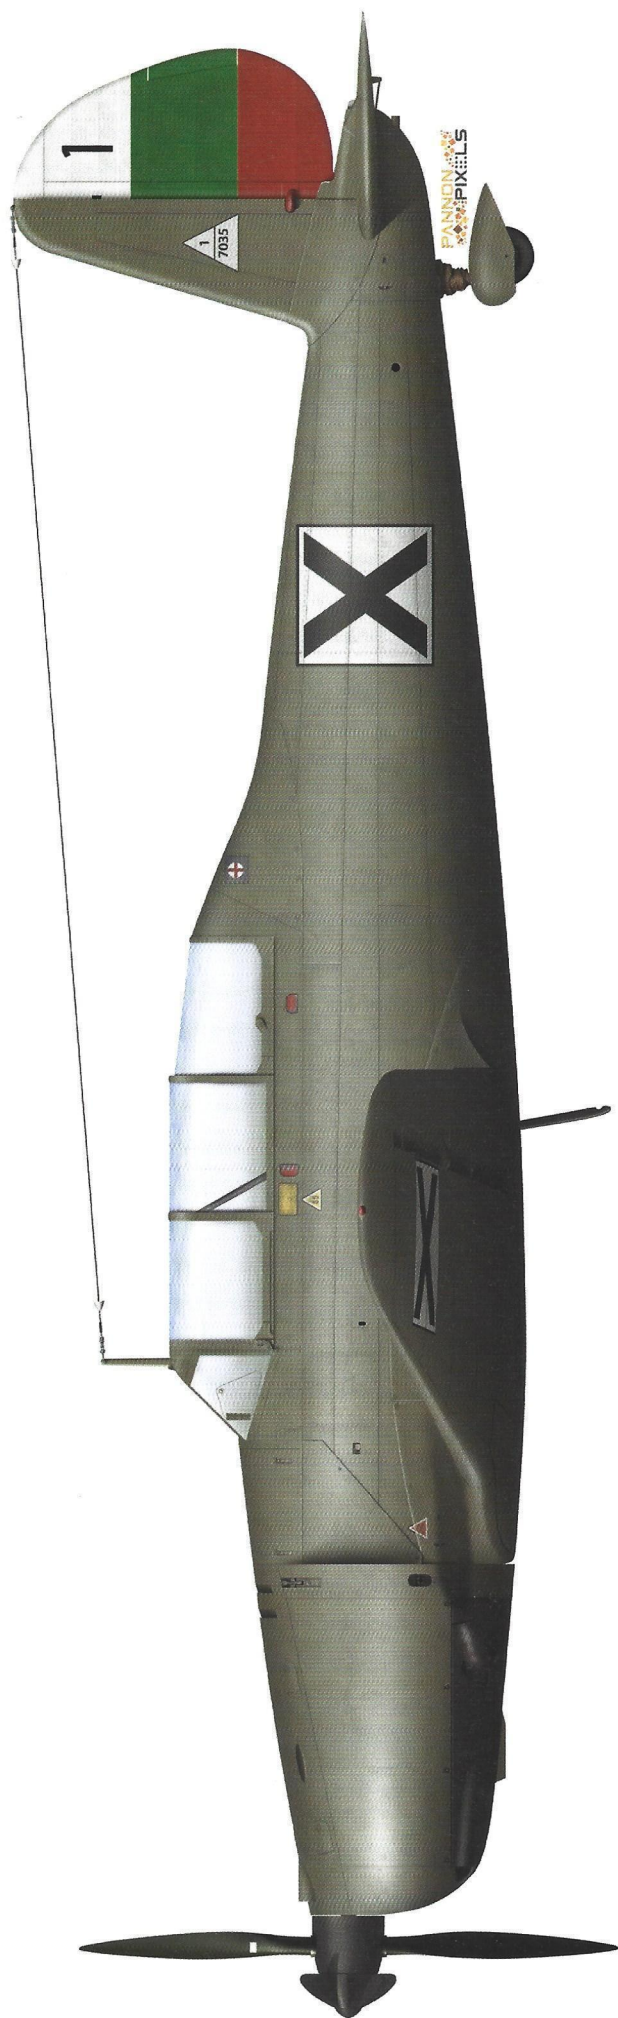
Arado Ar 96B-1, unarmed (W.Nr. 96 0060), 1/7035, 'Black 1', Bozhurishte, October 1940. Camouflage colours: RLM-Grey (RLM 02) overall. Spinner and propeller blades black. Axis style national marking in six positions. Rudder in Bulgarian tricolour (White, Green, Red).

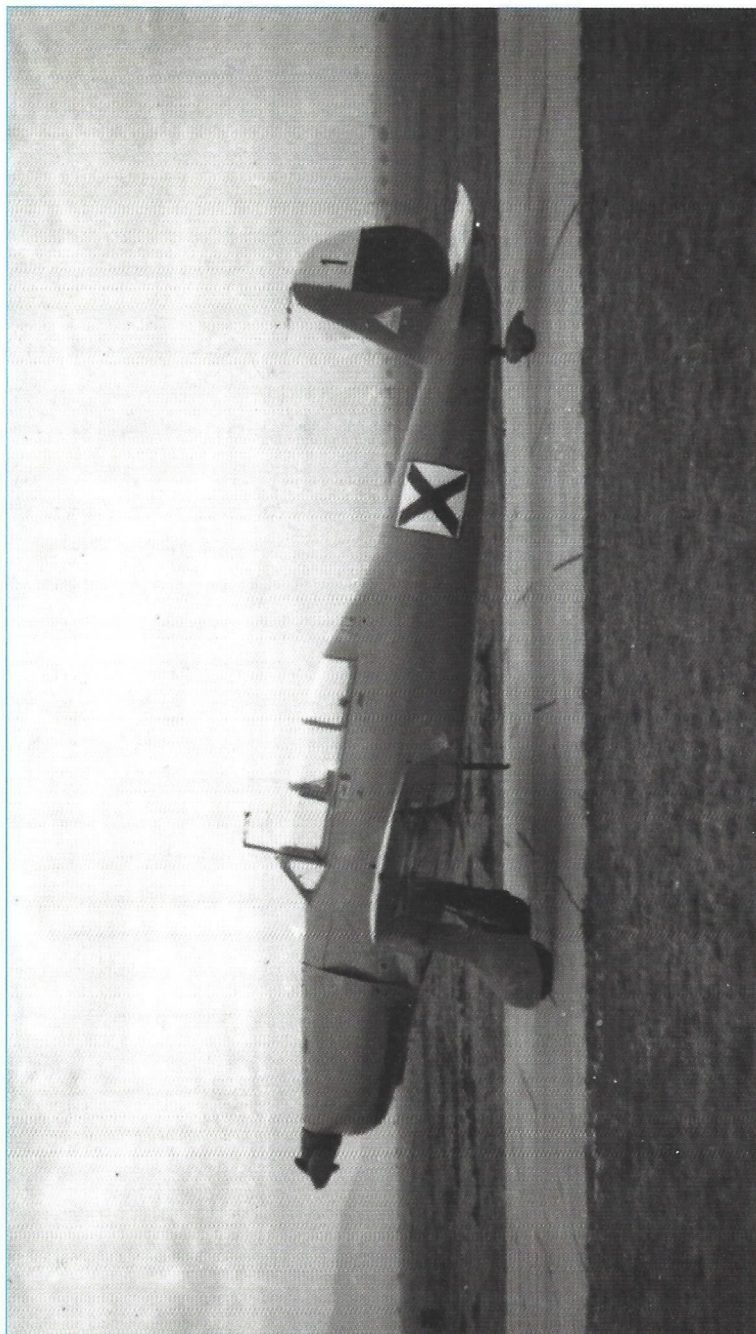
The factory applied roundel type Bulgarian military markings the aircraft arrived with from Arado Flugzeugwerke lasted only a couple of days, at most. They were replaced by the square type, valid at the time of the aircraft's arrival to Bulgaria. The aircraft's black individual serial number was applied first on the rudder top, over the white national colour segment, as per Order No. 53/14.04.1938. This practice also did not last too long, as soon after, the serial number was moved to the fuselage, where it stayed for the rest of the aircraft type's wartime service.

The early style, roundel type military marking was already *passé* by the time the Arados eventually arrived in late 1940. Therefore, it was immediately replaced with the current, Axis-style black cross in white square type marking. The black VNVV serial numbers were applied in Bulgaria, initially on the rudder top and on wing under surfaces. Later on, the serial number was moved to the rear fuselage, aft of the military marking, applied briefly in white, then in black.

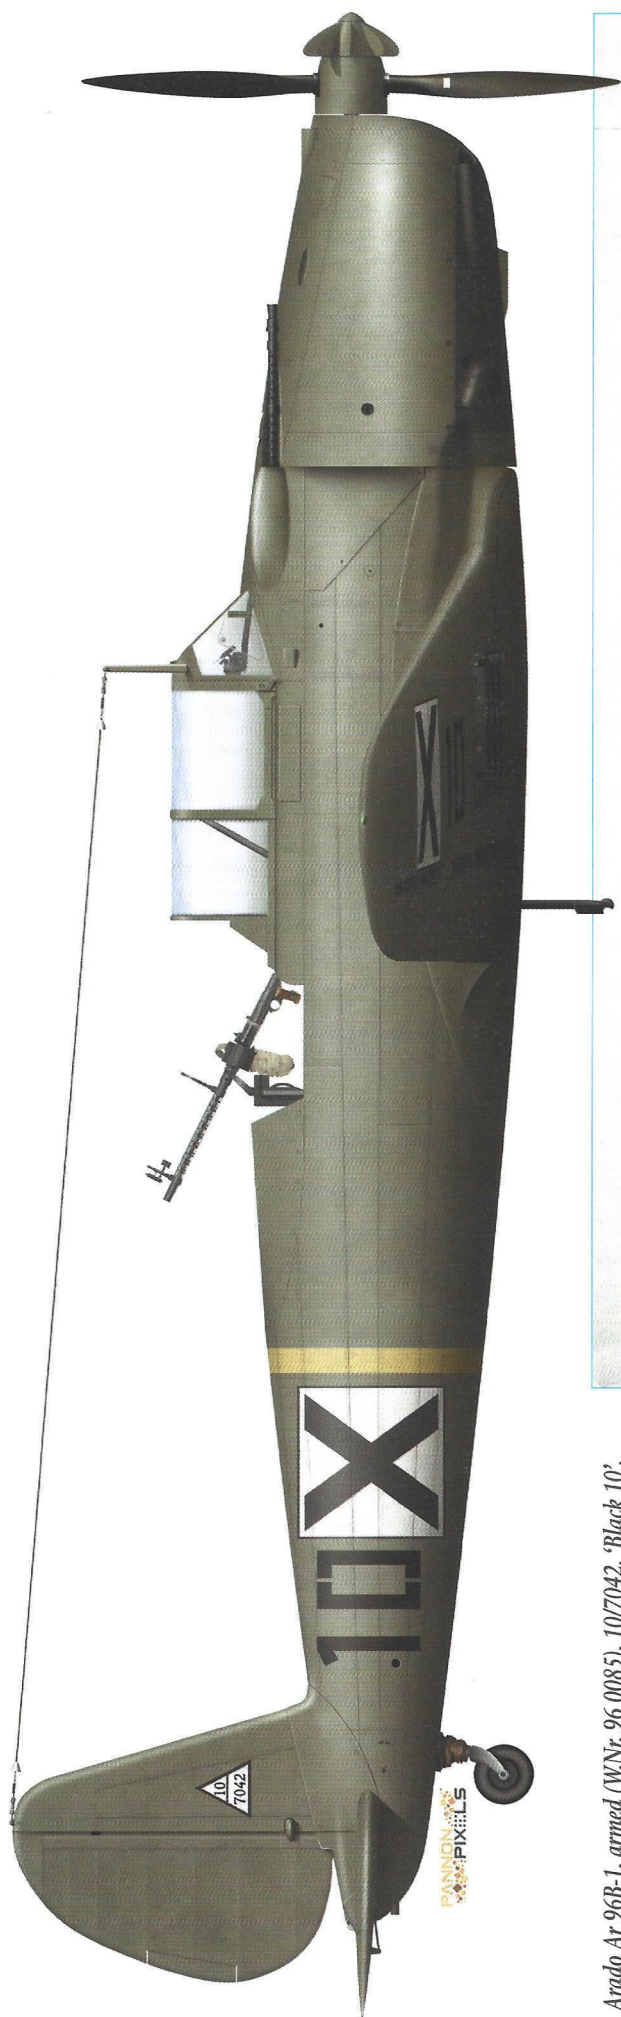
Arado Ar 96B-1, armed (W.Nr. 96 0085), 10/7042, 'Black 10', 1st Armeyski Orlyak, April 1941. Camouflage colours: RLM-Grey (RLM 02) overall. Thin yellow rear fuselage band. Propeller blades black. Axis style national marking in six positions.

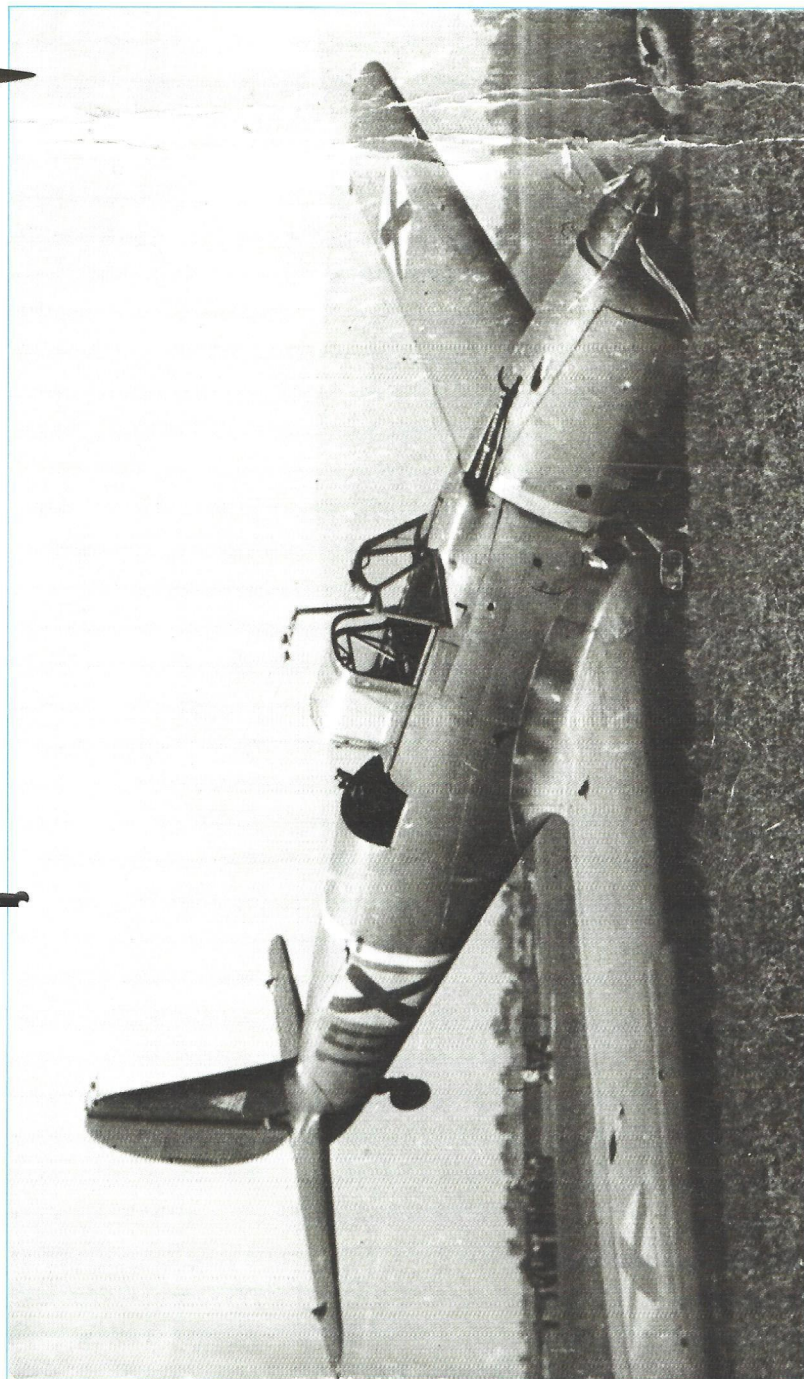
'Black 10' stopped on its nose following a botched landing sometime in 1941. This undated post-accident photo allows the onlooker to study many details of the armed version of the Ar 96B-1. Notice the narrow yellow mid-fuselage band applied in early April 1941, just prior to the invasion of Yugoslavia, to all Axis aircraft flying in the area, Bulgarians included. By that time, the vivid Bulgarian tricolour had disappeared from the rudder.

During the invasion of Yugoslavia by German troops in April 1941, a thin yellow band appeared on the mid-fuselage, often combined with a solid yellow engine cowling (either fully covered, or only the front 2/3rd area). Later, possibly from 1943 on, both surfaces of the wingtips became yellow as well, alongside the rudder and elevators. About ten days following Bulgaria's about-face and defection from the Axis camp on 9 September 1944, all 'Axis-yellow' paint was removed, and replaced with a white rear fuselage band, the same colour covering both surfaces of the wingtips.

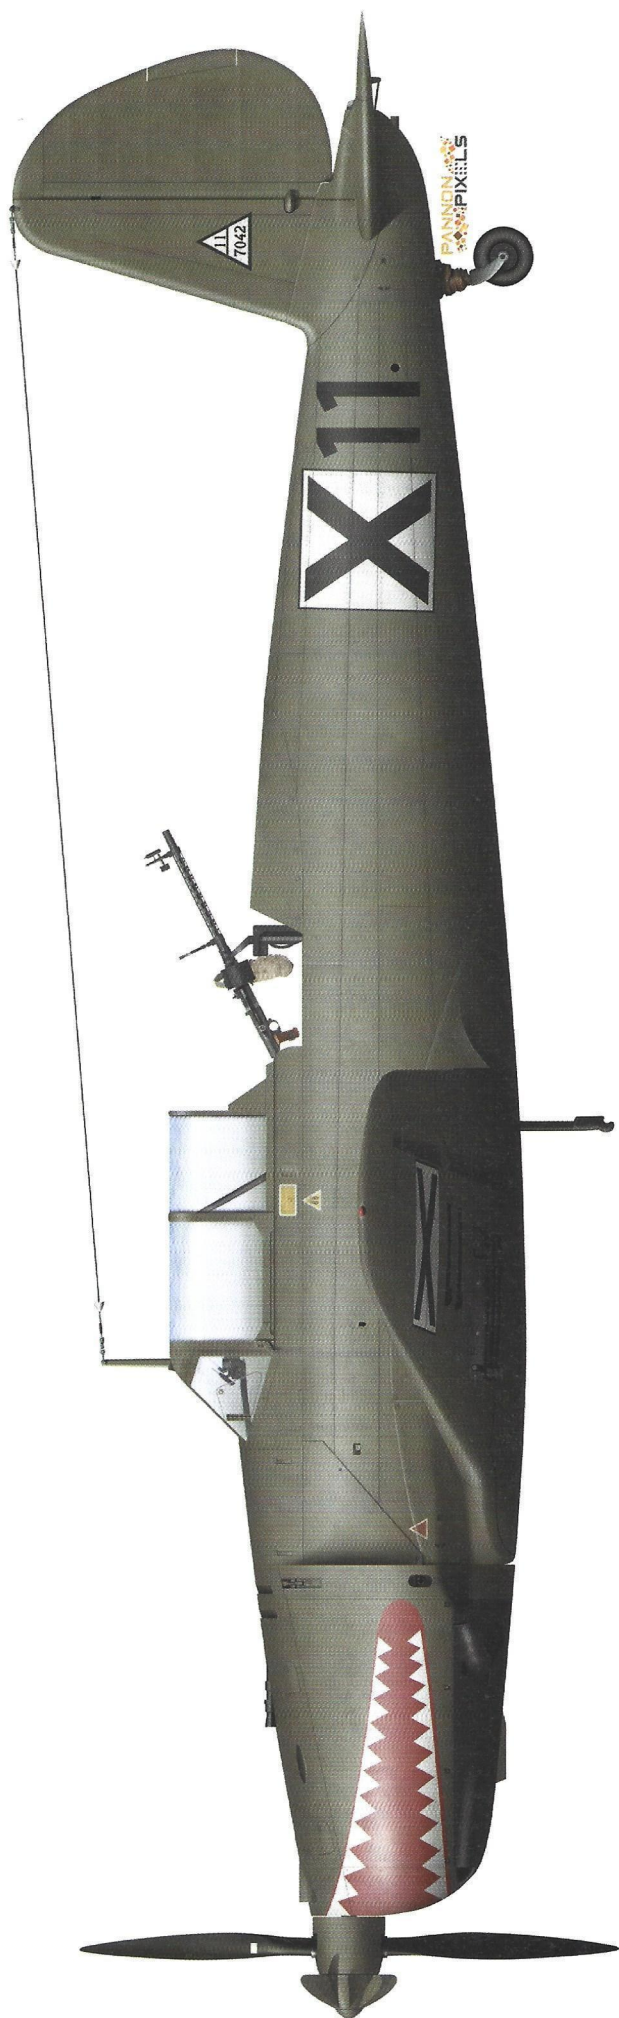
Arado Ar 96B-1, armed (W.Nr. 96 0092), 11/7042, 'Black 11', 2nd 'Lineen' Armeyski Orlyak, 1942. Camouflage colours: RLM-Grey (RLM 02) overall. Propeller blades black. Axis style national marking in six positions.

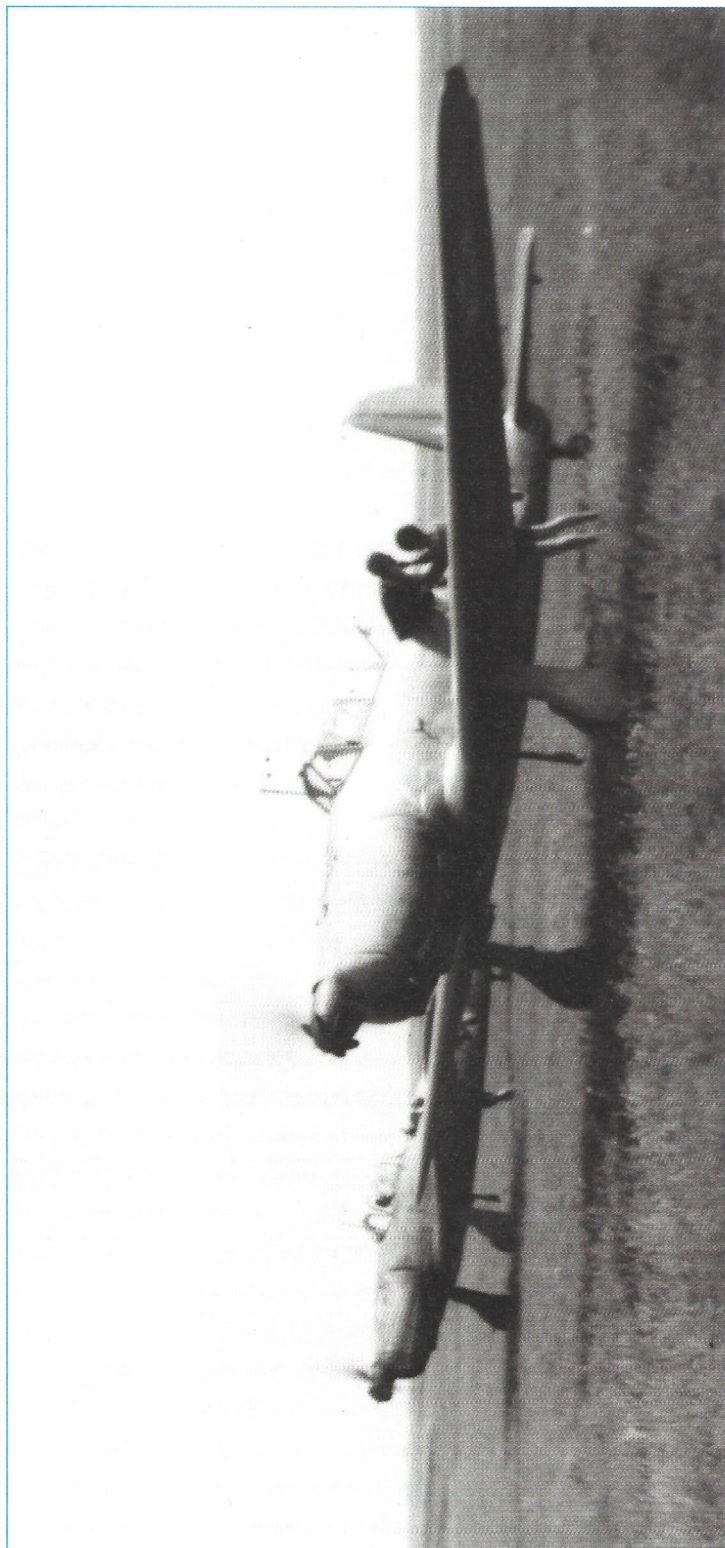
The Soyka in the rear appears to sport a spectacular marking, in form of a crocodile mouth painted on the engine cowling. The aircraft's individual serial number is believed to be 'Black 11'.

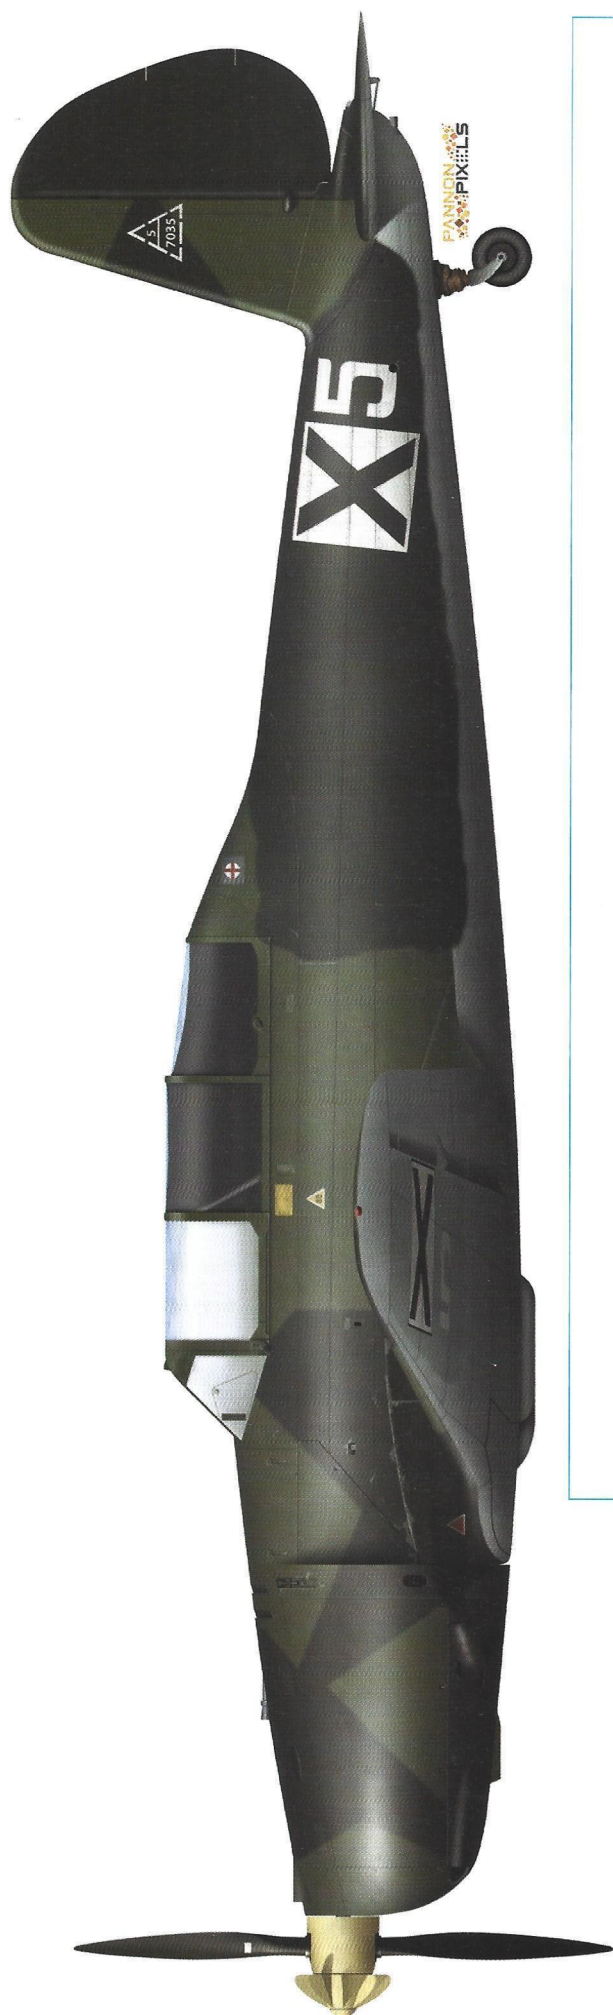
Arado Ar 96B-7, armed (W.Nr. 450006), 5/7035, 'White 5', mid-1944. Camouflage colours: Black Green (RLM 70) and Dark Green (RLM 71), over Light Blue (RLM 65). Propeller spinner yellow, blades black. Axis style national marking in six positions.

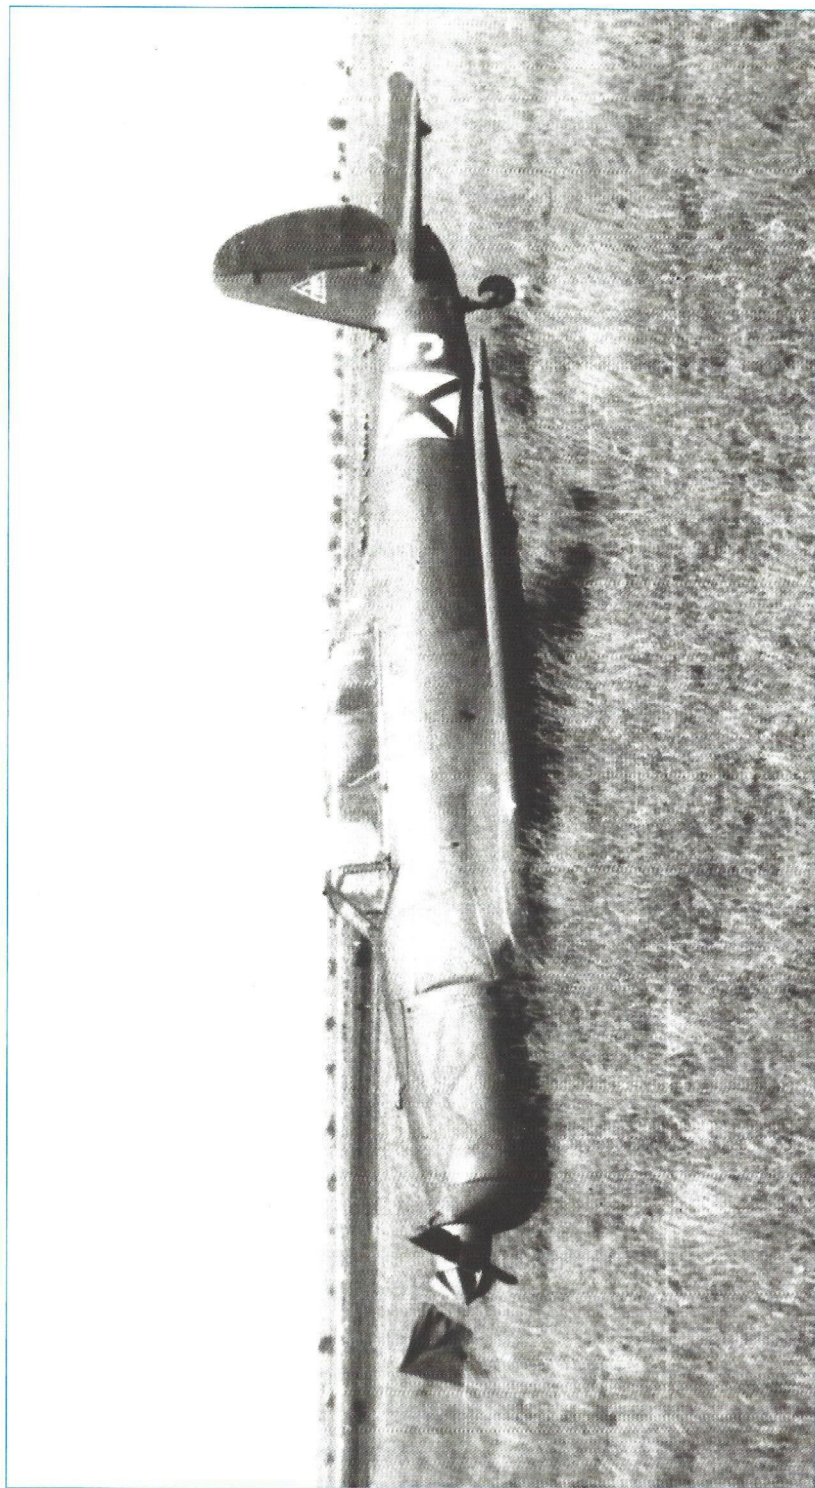
During the spring of 1944, ten Ar 96Bs were transferred to Bulgaria as part of the so-called 'Barbara-Programm'. This particular aircraft was most probably part of this delivery. The fuselage number 'White 5' denotes that this was the first such aircraft, as four unarmed B-1s had arrived much earlier, in late 1940 (Nos. 1-4). The barrel of the nose mounted MG 17 machine gun protrudes over the starboard side of the engine cowlings. This detail points to the sub-version possibly being a B-3 (the similarly armed B-8 appeared only later on), in contrast to the German delivery documents, which state the sub-type of these ten aircraft delivered in 1944 as the unarmed B-7. Notice the black curtains in the rear cabin, consistent with blind flying training. Despite the indifferent quality of the photo, the standard Luftwaffe style segment camouflage pattern is recognisable.

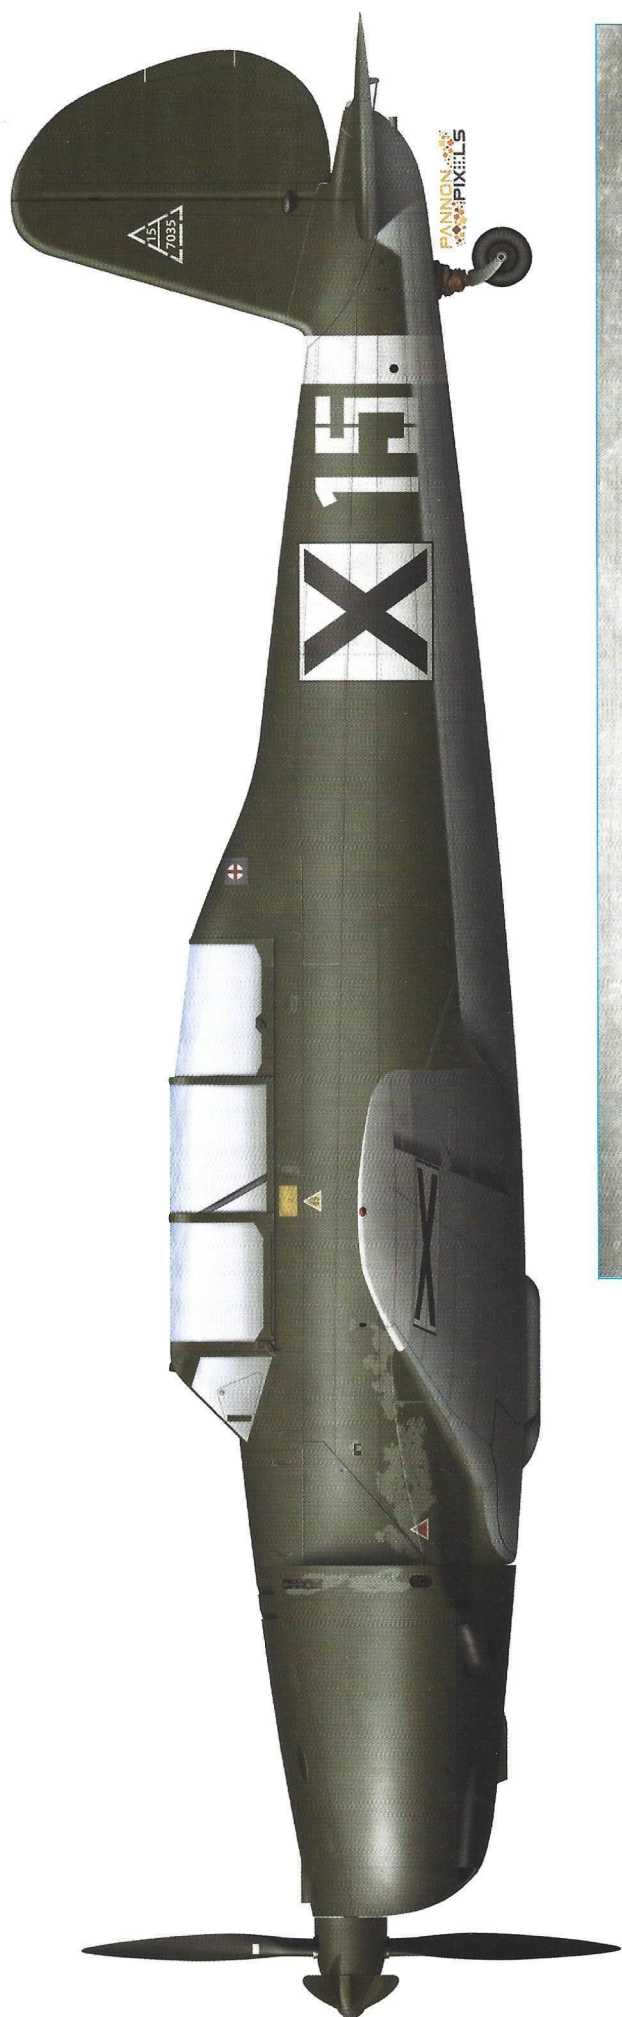
Arado Ar 96B, unarmed, 15/7035, 'White 15', mid-1945. Camouflage colours: unidentified Dark Green, over Light Blue. White rear fuselage band and wingtips. Propeller blades black. Axis style national marking in six positions.

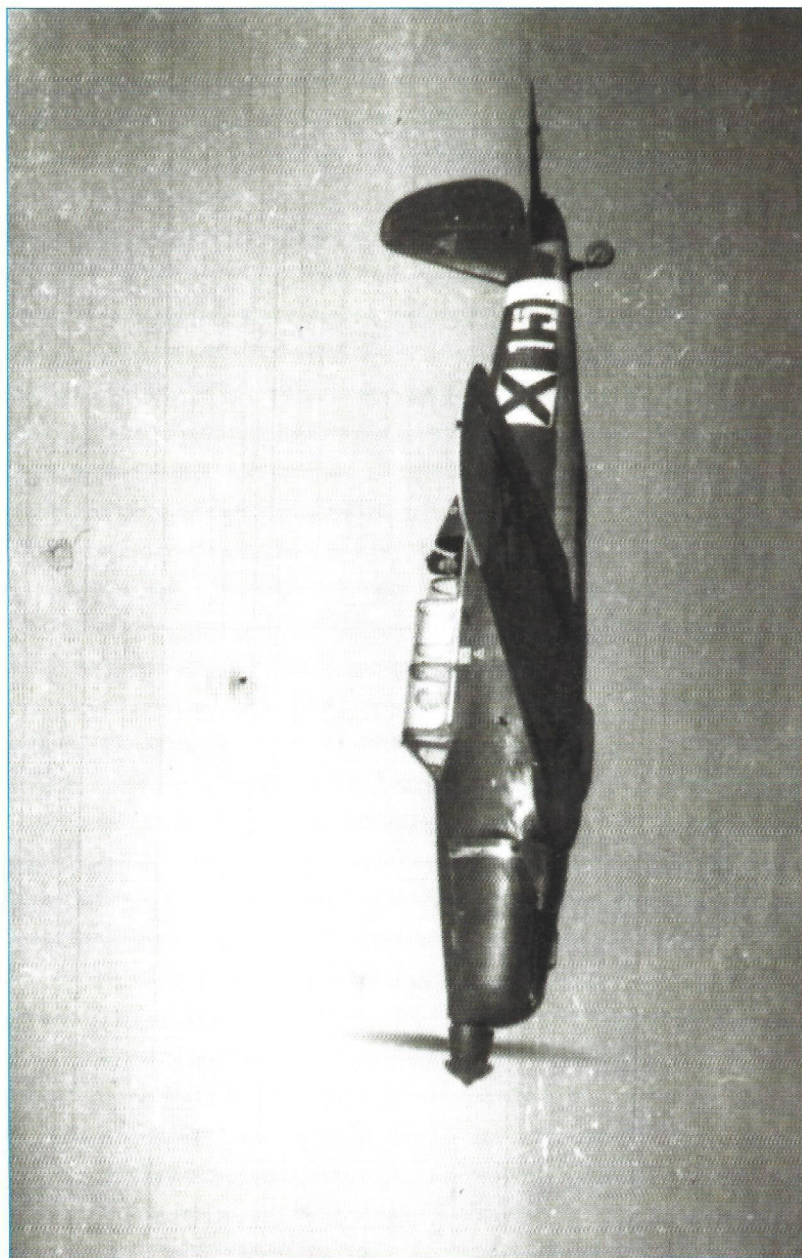
Judging by its serial number, 15, this Ar 96B was the first aircraft coming from the captures in Austria, impressed in Bulgarian service in mid-1945 (the first four arrived from Germany in 1940, the next ten in 1944). The white wingtips and fuselage band date the photo as post-September 1944, when these pro-Soviet markings have been introduced – consistent to the aforementioned theory. The aircraft appears to be painted on the upper surfaces in a uniform dark green colour, over light blue, or grey. The dividing line of these two colours runs unusually high on the fuselage side, pointing to a paint job performed in Bulgaria. The woman in the rear seat apparently enjoys the ride with the open cockpit. This may hint to warmer temperatures, thus placing the time of this snapshot sometime in the summer of 1945.

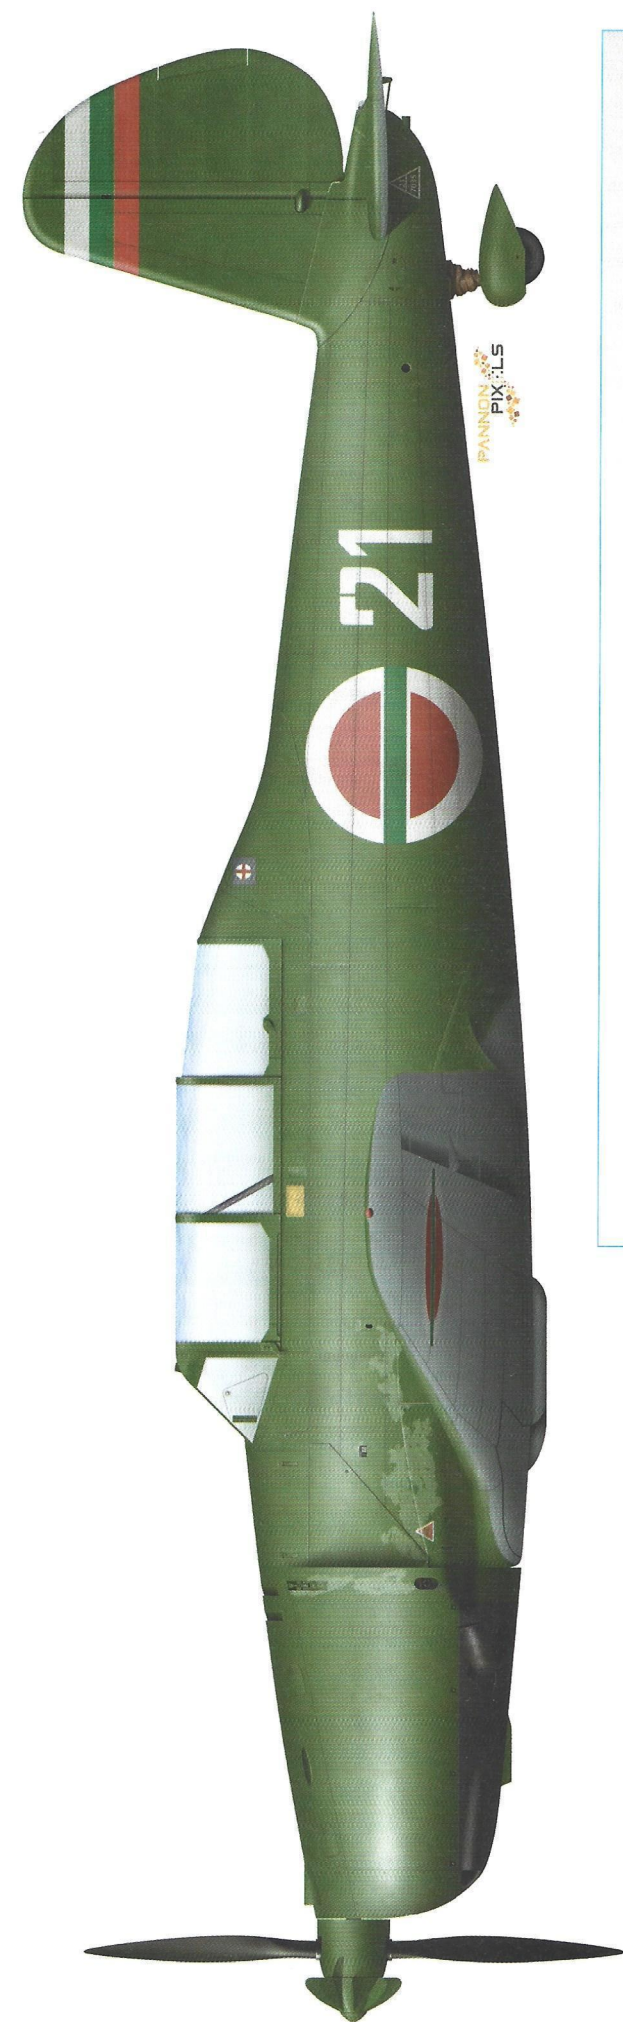
Arado Ar 96B-7, unarmed (W.Nr. 55 0448, formerly GM+VN), 21/7035, 'White 21', Văzdushnata Shkola (Air School), Telish. Crew: instructor Podporuchik (2nd Lieutenant) Slavcho S. Slavchev and Uchenik letets mladshii kursant (Student airman junior cadet) Hristo T. Gramatikov, Rakita, 26 May 1950. Camouflage colours: unidentified Dark Green wraparound on fuselage over Light Blue on wing under surfaces (possibly of Soviet origin). Thin horizontal stripes in Bulgarian tricolour across the top tail surface. OF-style national marking in four positions.

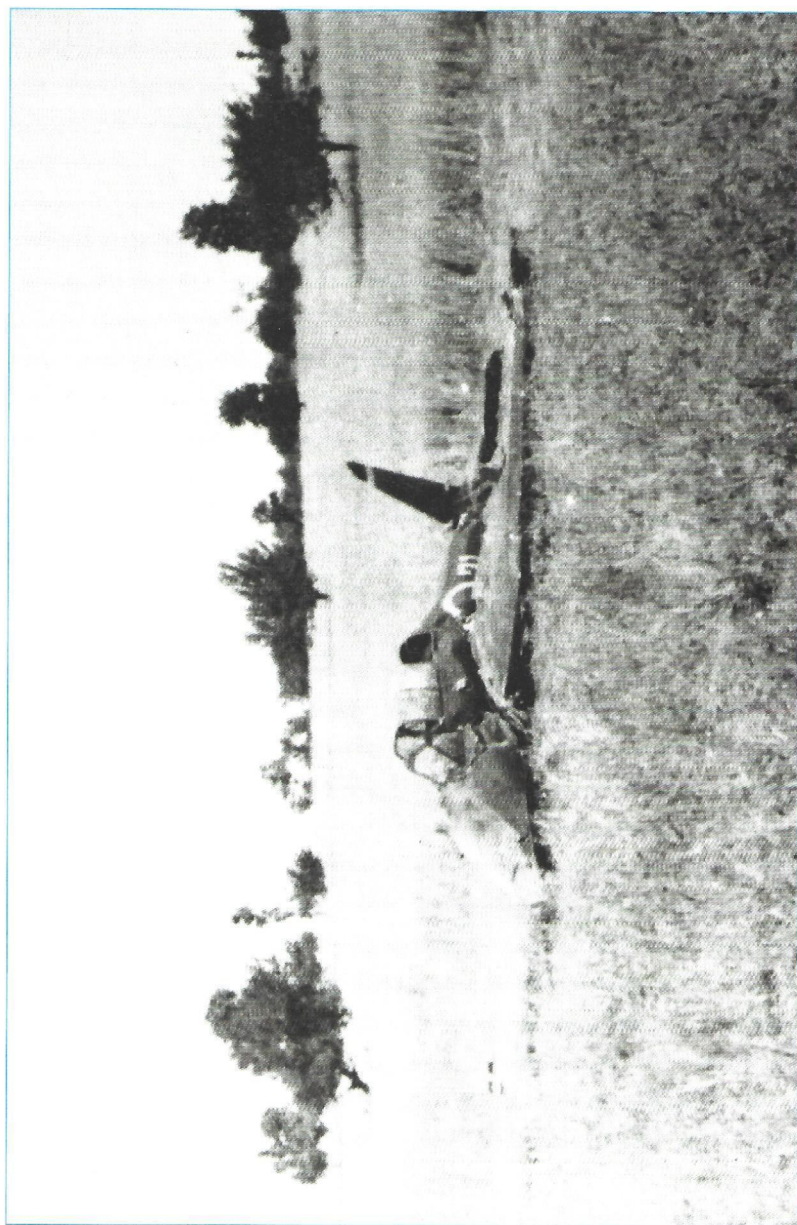
This deadly accident involving a Soyka happened on 26 May 1950. It concerned a 'trophy' Ar 96B-7, No. 21/7035, of the Telish based piloting school. Both crewmembers died in this accident that happened near Rakita, 35 km west of Sofia. The aircraft was in Bulgarian service since 17.08.1945. See page 242 top for another photo depicting the same catastrophe. Curiously, the white serial (board) number is applied on the rear fuselage, aft the military marking, and not in front of it, as per official regulations. The ubiquitous triangle most probably ended up underneath the horizontal stabiliser (tailplane).

The second and last fatal accident involving a Bulgarian Ar 96 happened as late as 26 May 1950. That day, during a regular training flight, the worn engine of Ar 96B-7, No. 21, stopped in mid-flight, at 150 m altitude. The aircraft then stalled and crashed near Rakita. Unfortunately, both crewmembers, *Uchenik letets mladshi kursant* (Student airman junior cadet) Hristo T. Gramatkov and instructor *Podpor.* (2nd Lt.) Slavcho S. Slavchev, were killed. The doomed *Soyka*, impressed in Bulgarian service on 17.08.1945 (thus a 'trophy' aircraft), was a total write-off (see photo and artwork on page 250).

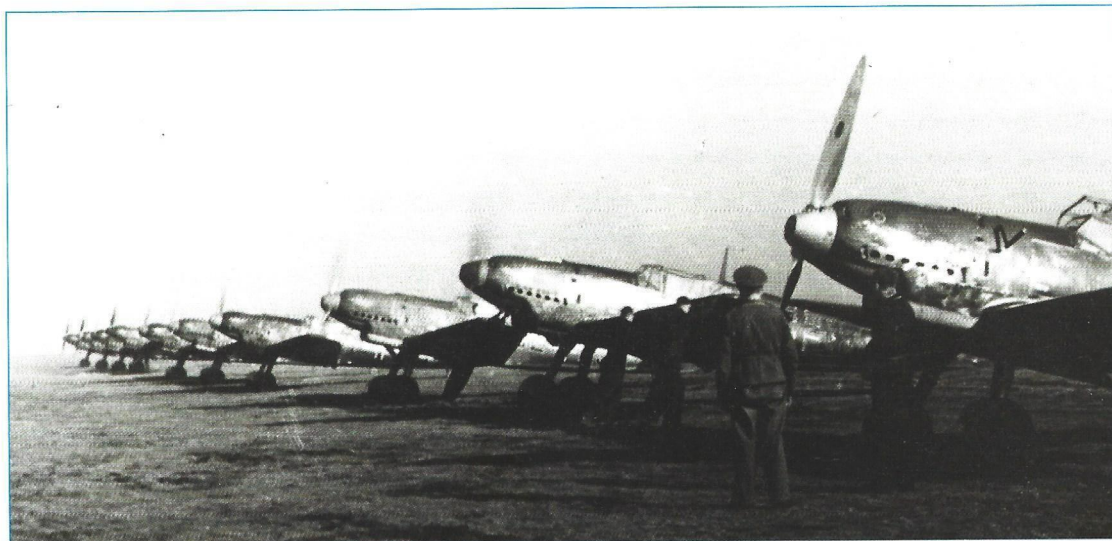
This photo originating from Bulgaria depicts a neat row of ten Messerschmitt Bf 109D fighter aircraft, used by Bulgarian pilots for conversion training, lined up on Werneuchen airfield. The nearest aircraft wears on its rear fuselage the S2+M58 code, while the one behind it S2+M53 (outlined in white).

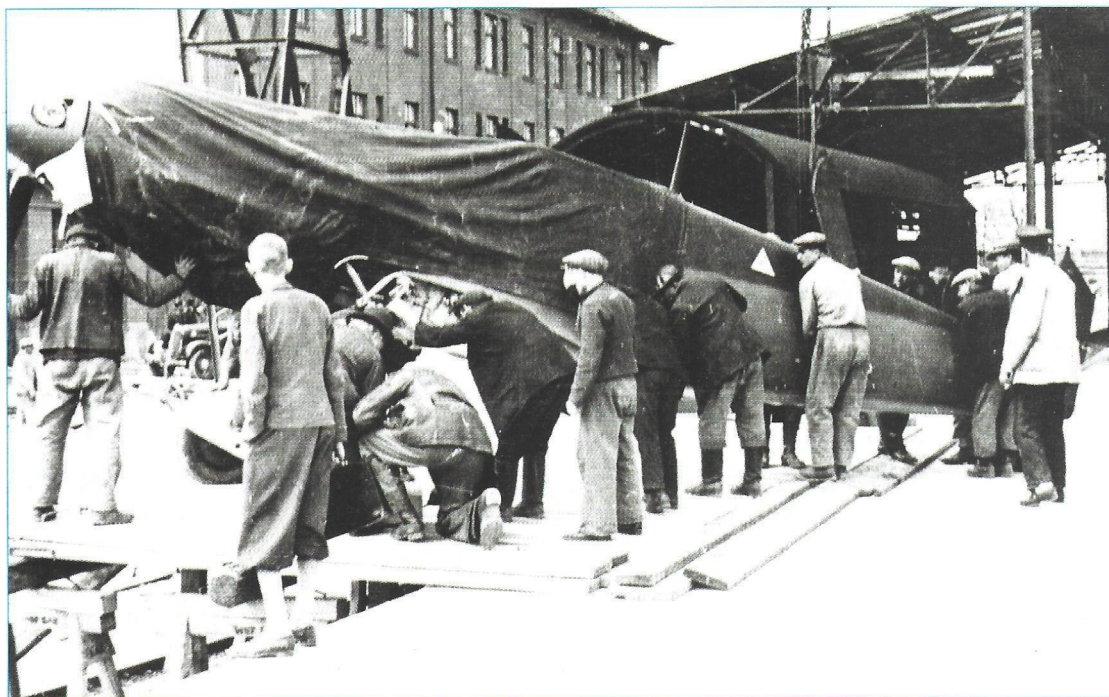
Austrian workers prepare the fuselage of an Emil to be loaded upon a flatbed railway carriage prior to shipment to Bulgaria. Notice the typical Bulgarian camouflage scheme on rear fuselage and the lack of military markings. The propeller is painted in a light colour, definitely not black green, as it should have been according to Luftwaffe standards.

The ten commissioned Bf 109E-3s were delivered from the WNF aircraft factory at Wiener Neustadt, in Austria, to Bulgaria in late April 1940. They arrived already painted in camouflage colours, but devoid of any serial numbers or national markings (except for the rudder, which was painted in Bulgaria's tricolour). They also lacked the 20mm wing cannon, which were purchased and fitted only later on. This detail is visible on this head-on photo, taken shortly after assembly at DSF-Bozhurishte. For the side view of the same aircraft, see page 282, top.

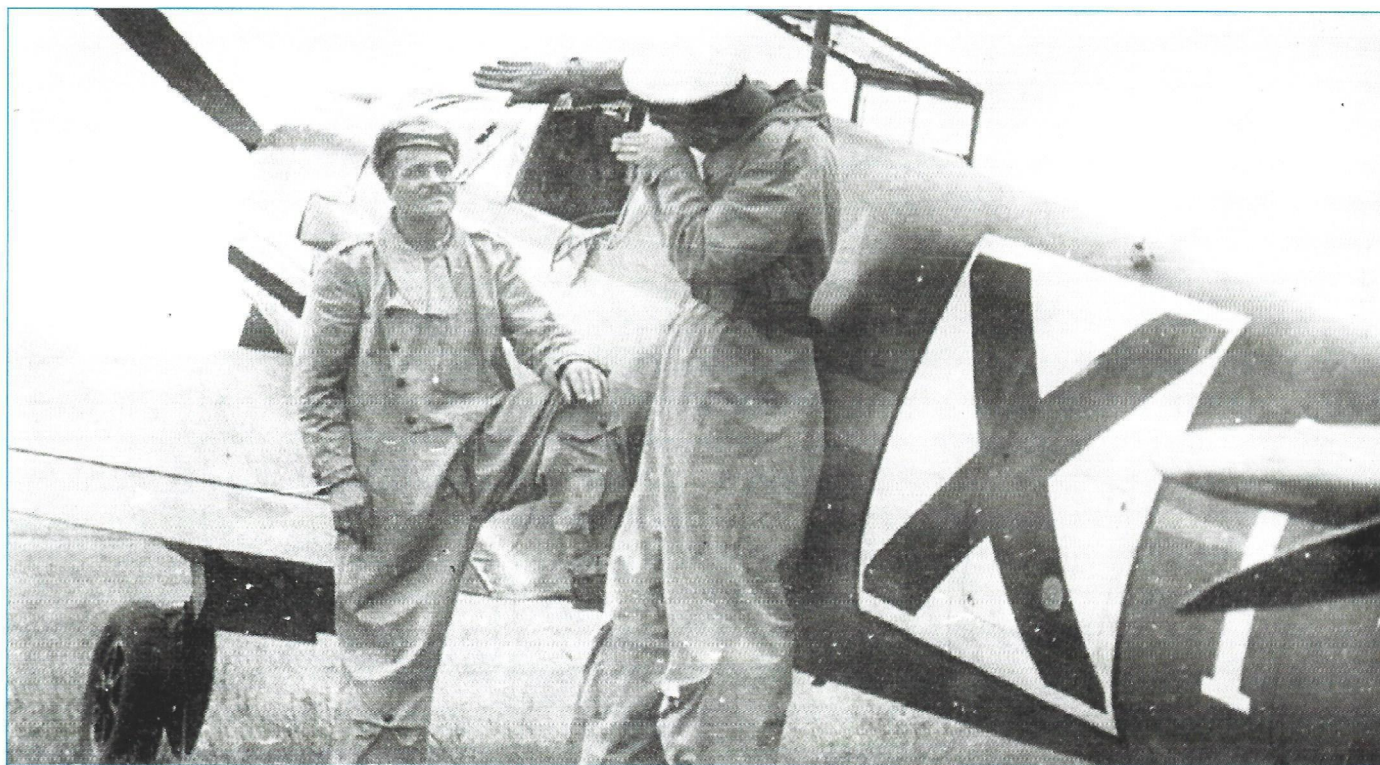
Just weeks after the Messerschmitts had been commissioned in Bulgaria and identified with the early style roundels of the VNVV, the marking changed to a square shape, featuring a large, black St. Andrew's cross in a white square, bordered with thin black line. This new marking is depicted on the first Bf 109E-3, W.Nr. 5221. The Bulgarian pilot at right does what fighter pilots all over the world do: recalling a particular manoeuvre by mimicking the aircraft with his hands.

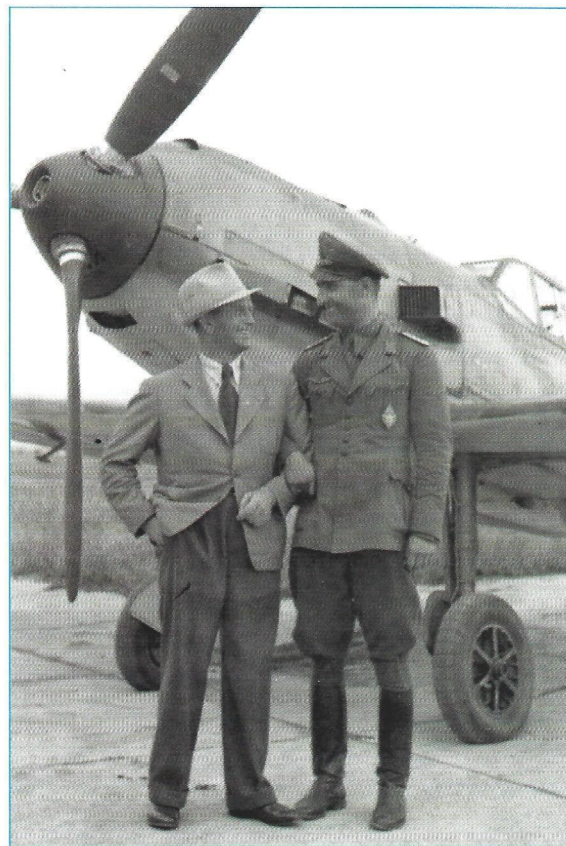
A happy Bulgarian officer, believed to be the venerable *Cpt.* Petko N. Popganchev, links arms with an equally happy civilian man, most probably a disguised German pilot, in front of one of the recently assembled *Strelas*. The 'St. Andrew's Cross' type marking is faintly visible on the starboard wing's under surface. The engine cowling was not yet painted yellow. Concomitantly, the yellow "arrow" is missing as well from the fuselage side.

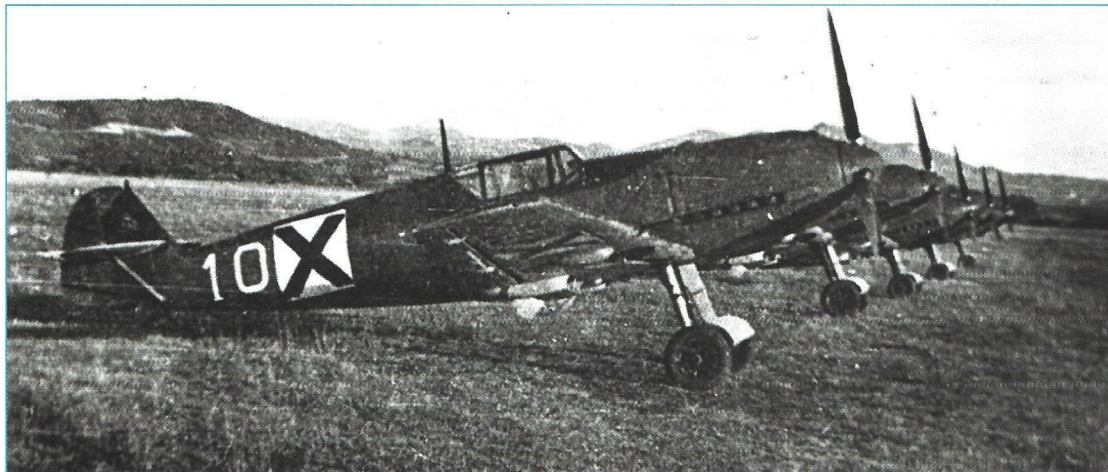
The last aircraft of the first batch (No. 10) is flanking others on Marno Pole (Karlovo) airfield, located in a mountainous region. When 692. Yato was formed in October 1940, the ten extant '109s were split in two, and assigned in equal number to both squadrons (yata), namely 682nd and 692nd.

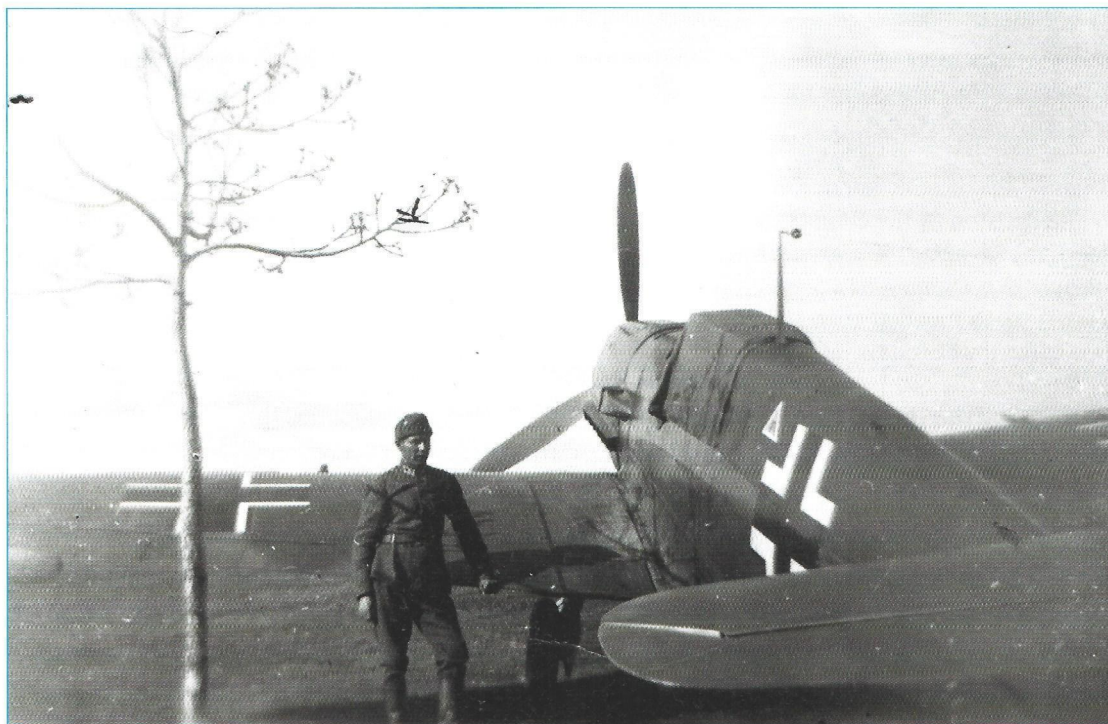
This photo has no explanation to date. It was certainly taken in Bulgaria (the original photo comes from there), there is a Bulgarian soldier standing at the port wing. The Emil sports the typical yellow decoration adorning Bulgarian fighters; however, it displays Luftwaffe crosses, but no individual serial number. Unfortunately, there is nothing written on the reverse of the original photo; therefore, the Author could not find a plausible explanation.

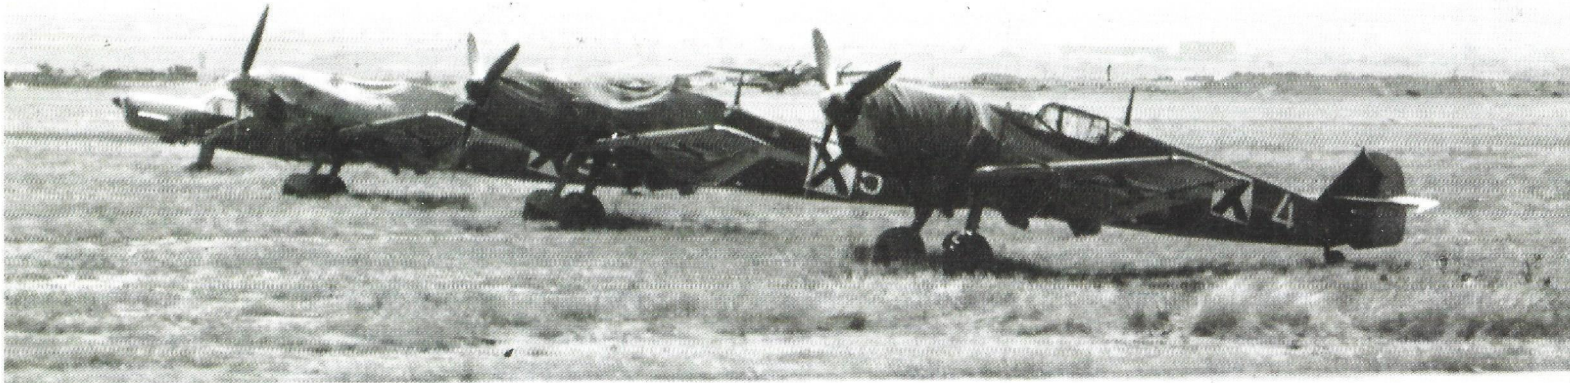
Strela No. 5 appears again in this shot, this time flanked by No. 4 and another unidentified one, parked on Karlovo airfield. At the far side of the row, a Bf 108B Taifun trainer is visible. The difference in fuselage markings sizes between Nos. 4 and 5 is noteworthy.
